Manhole Inspection Summary

Manhole # S15YY_025MH

Insp Date: **7/10/07 9:54 AM**

Location Address: **2927 NORFOLK AVE**

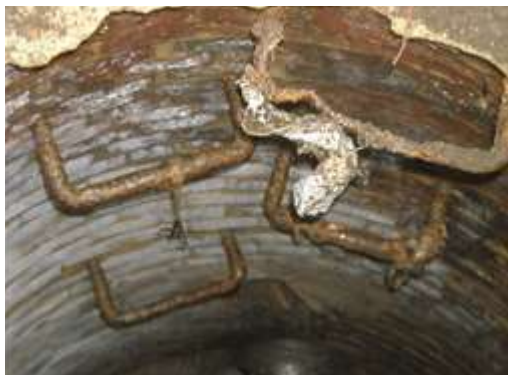
Defect 4

☒ **Evidence Of Surcharge** Depth: **6** (ft.) ☐ Active Surcharge Present

EVIDENCE OF ASUR

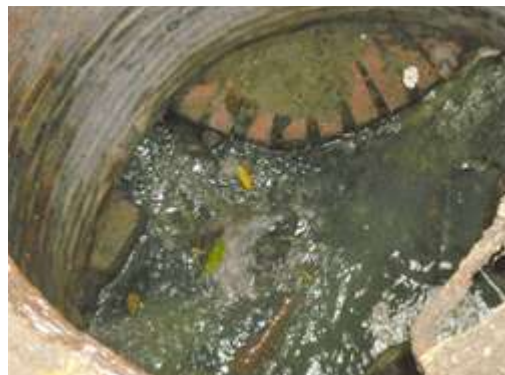
Defect 3

Condition: ☐ Sound ☐ Cracked ☐ Root Intrusion ☐ Deteriorated ☐ Leaks ☒ **Debris**

DEBRIS ON BENCH

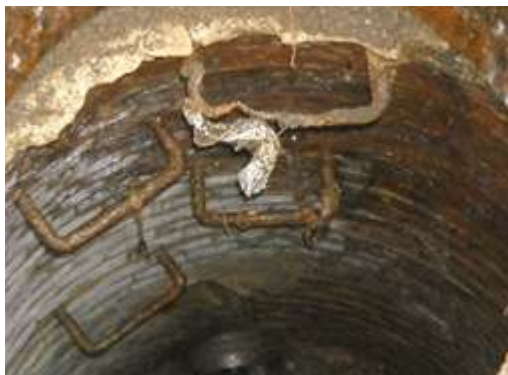
Defect 2

Count: **4** Missing: **0** ☒ **Corroded**

CORRODED STEPS

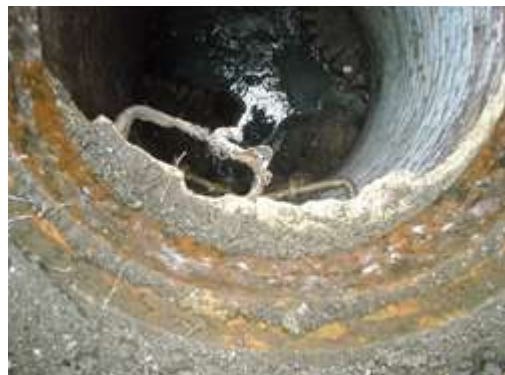
Defect 1

Offset: **2** (in.)

Condition: ☐ Sound ☐ Cracked ☐ Root Intrusion ☐ Loose Brick ☒ **Deteriorated**

FRAME OFFSET AND DETERIORATED CHIMNEY

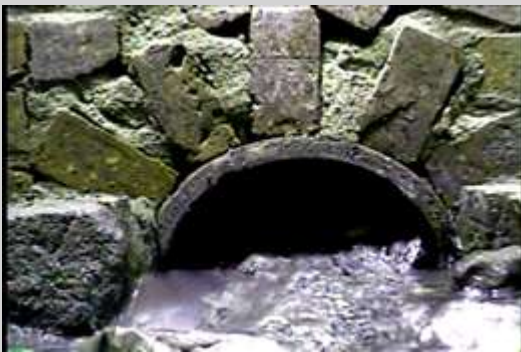
12 O'Clock Outflow

Pipe Height: **7.2** (in.) Rod and Bar (Angled)
Pipe Material: **Clay** ☐ Pipe Lined
Invert Depth: **8.53** (ft.) Flow Characteristics: **Slow**
Deposits: ☐ None ☐ Mud ☒ **Sludge** ☒ **Debris** ☐ Grease
Silt Depth: **5** (in.) Deposits Extent: **Medium**
Infiltration: **None** Pipe Seal Cond: **Sound**

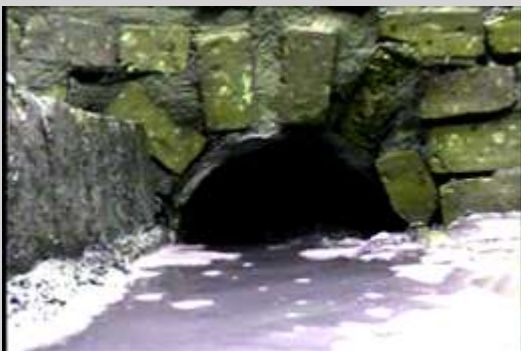
3 O'Clock Inflow

Pipe Height: **7.2** (in.) Rod and Bar (Angled)
Pipe Material: **Clay** ☐ Pipe Lined
Invert Depth: **6.21** (ft.) Flow Characteristics: **Slow**
Deposits: ☒ None ☐ Mud ☐ **Sludge** ☐ Debris ☐ Grease
Silt Depth: (in.) Deposits Extent:
Infiltration: **None** Pipe Seal Cond: **Sound**

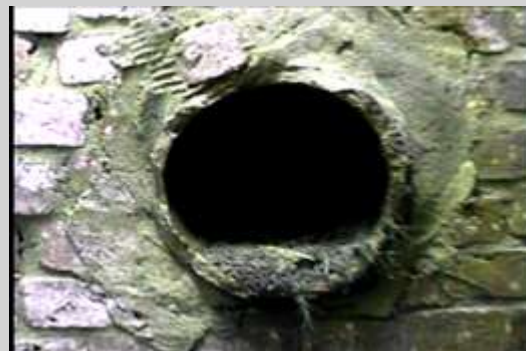
Pipe In @ 3 O'Clock

Drop: **Outside** Rod and Bar
Angled: **Yes** Reading: **7.04** (ft.)
Inv Depth: **8.04** (ft.)

Drop Condition: **Open**

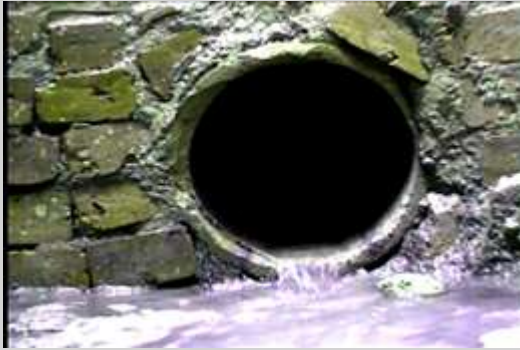
Pipe In @ 6 O'Clock

Deposits: ☐ None ☐ Mud ☒ **Sludgy** ☐ Debris ☐ Grease

Silt Depth: **3** (in.) Deposits Extent: **Light**

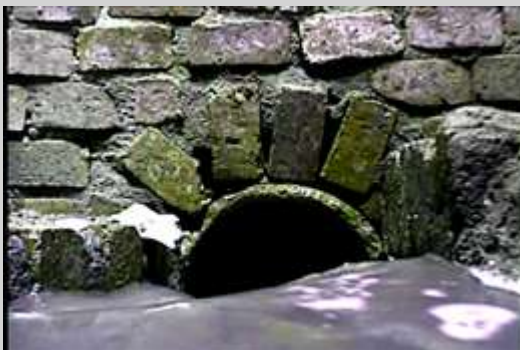
Pipe In @ 8 O'Clock

Pipe Seal Cond: **Broken**
